#### OFFICE OF THE FIRE MARSHAL

# HAZARD ALERT

Manufacturer: DUCANE

Manufacturer's #: TB7212269712 Mfg. Address: South Carolina Model Number: UHZB085A3BK

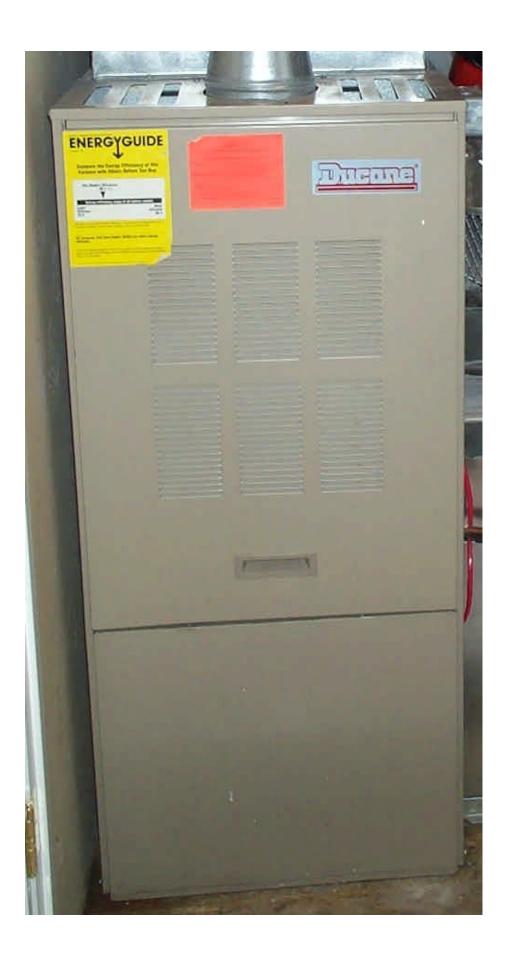
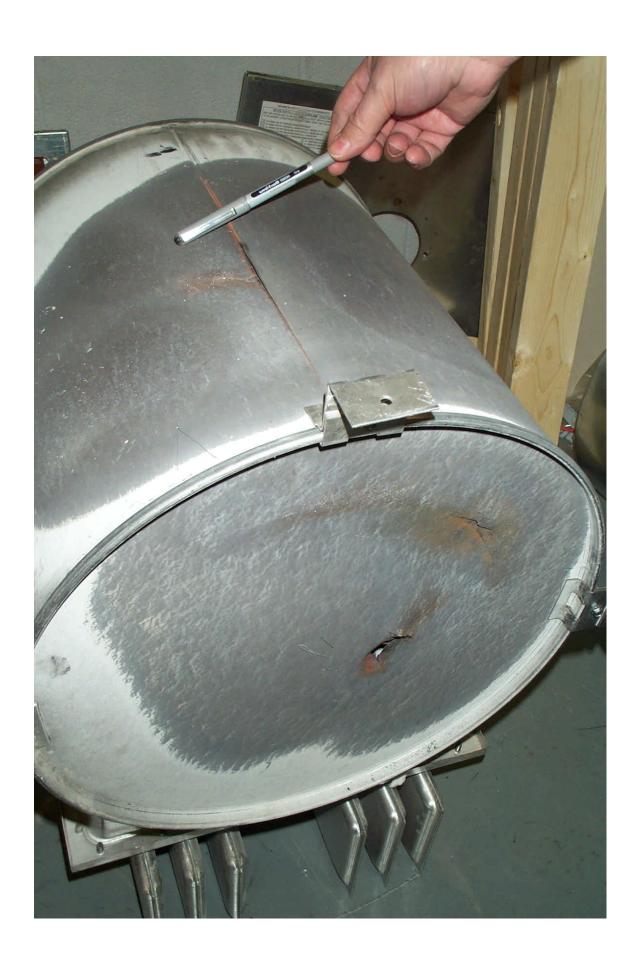
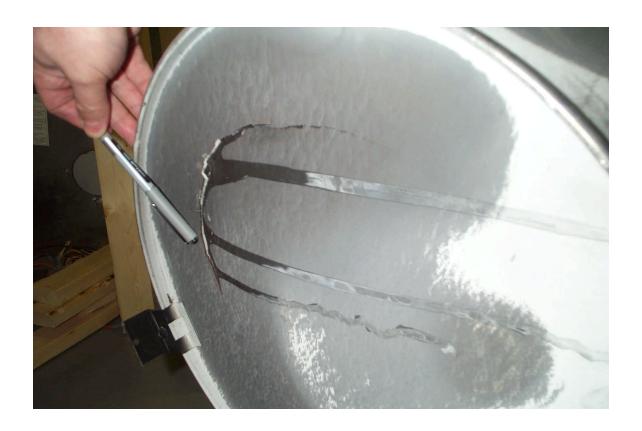
On inspection, a significant number of Ducane furnaces have shown cracks and breaching of the aluminized steel primary heat exchanger. The furnace in question may also show evidence of cracks and degradation of the combustion chamber.

Cracks and breaching of the primary heat exchanger may introduce toxic carbon monoxide fumes into the living environment. Severe breach of the primary heat exchanger may ignite combustibles in the vicinity of the furnace.

- 1. Install a functioning Carbon Monoxide Alarm in your home in the vicinity of a heat register duct.
- 2. Have a qualified oil burner mechanic inspect your furnace.
- 3. If the inspection reveals that the furnace is defective, contact the supplier of your Ducane furnace for warranty or replacement information.
